## Hole-by-hole

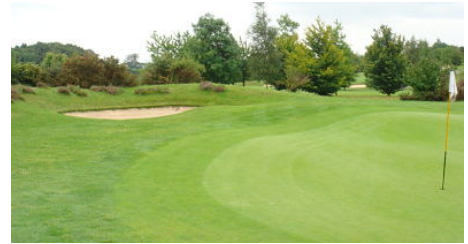
### **Rear greenside bunker on left**

This bunker is causing problems and is becoming unplayable with clay coming up from below. It is being considered whether to turf it over, but leaving the contours in place. It may also be effective to allow the grass to grow in this area.

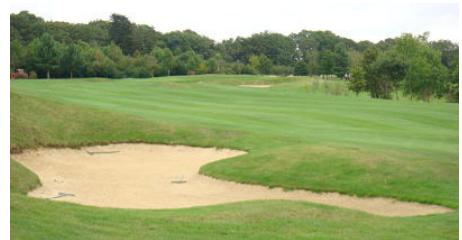
### **1<sup>st</sup> bunker on left at top of the hill**

This has bad drainage, due to the clay. The water regularly collects in it. This compacts the sand and leaves it hard when dried out. It will require re-basing and so will be made GUR whilst this is carried out. **NOTE** Do not assume they are GUR unless you see a sign to that effect. It will also be re-edged.

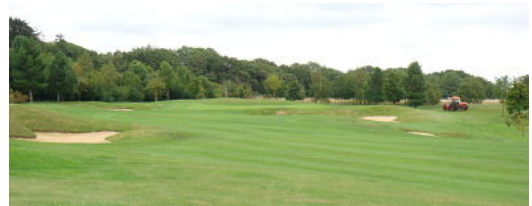
### **1<sup>st</sup> bunker on right, in dip**

As per both bunkers above

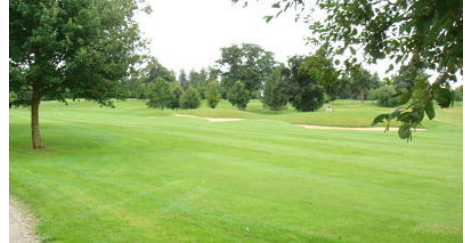
### **Fairway around the dogleg, opposite huge bunker on right**

Again this area suffers from bad drainage. This is due to the drains running into the river, alongside the fairway. Once the river level reaches the drains, the problems occur.

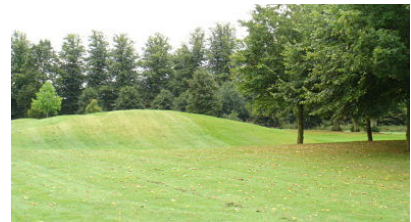
### **Old bunker area on right at dogleg**

This area, between the end of the trees by the 13<sup>th</sup> green and the start of the mound separating the 16<sup>th</sup> and 13<sup>th</sup> fairways, will have a small, shallow bunker put in.
